**Licensed Electrician Dies  
When Electrocuted by 480Volts  
Incident Number: 03KY115**

**Kentucky Fatality Assessment and Control Evaluation (FACE) Program**  
**Incident Number: 03KY115**  
**Incident Date: July 4, 2003**  
**Release Date: October 22, 2004**  
**Subject: Licensed Electrician Dies When Electrocuted by 480Volts**

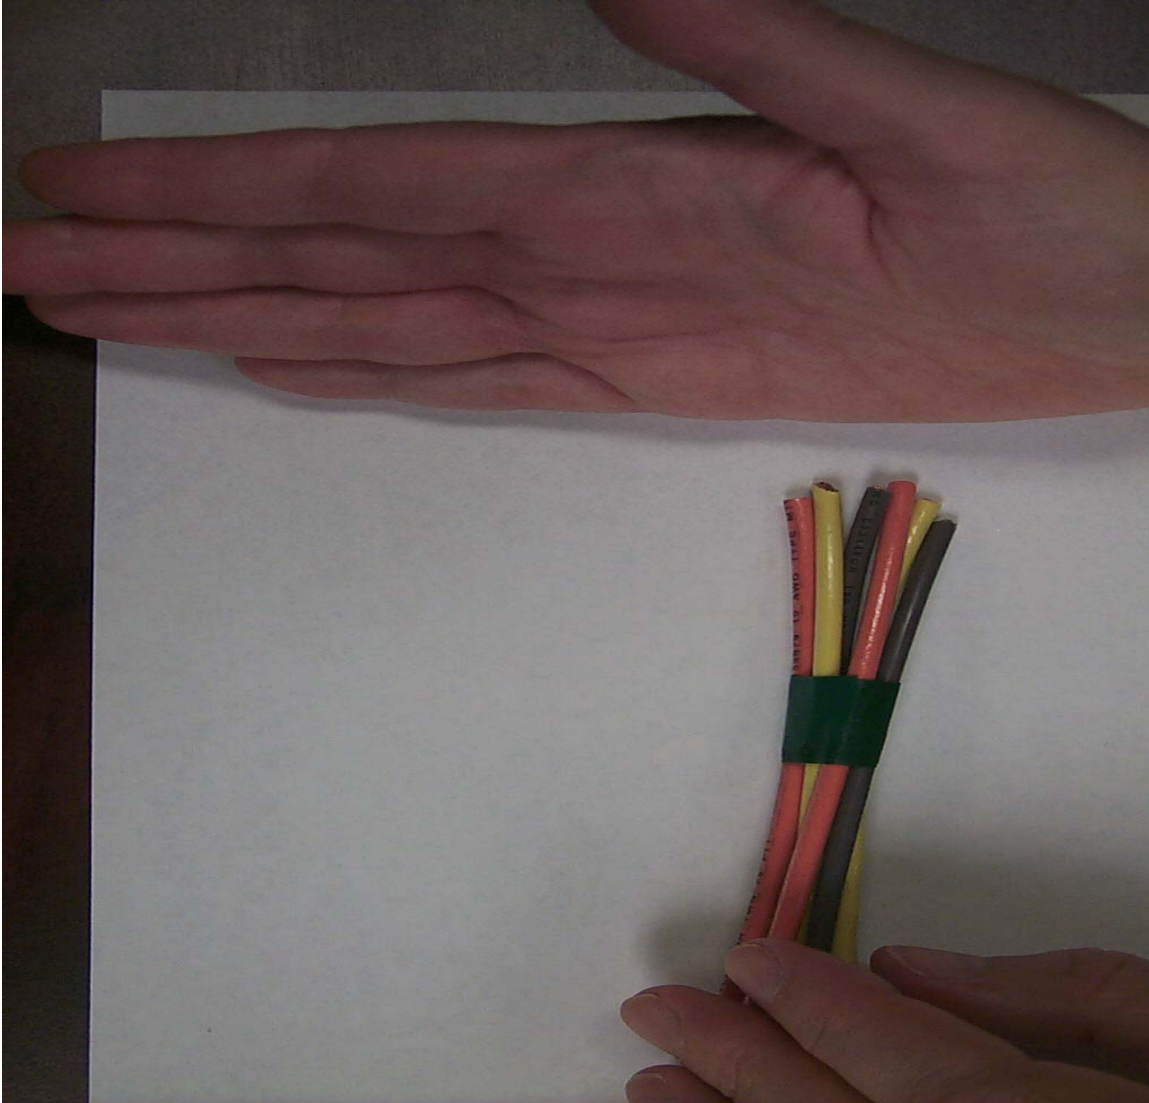
An example of wires lead electrician was taping in his palm when he was electrocuted.

It was a hot and muggy morning and the decedent was hot, sweaty and not wearing a shirt. After running wires and completing connections for the lighting service from the main building breaker panel to the new addition, the two electricians in the junction box began pulling wires for the two air conditioning units. The lead electrician was pulling the wires for the air conditioning service from the breaker box in the main building and was getting ready to connect the wires to the new wiring in the addition. As he pulled the wires into the junction box, he routed the wires under his legs, tapping the ends of the wires into his right hand to make them even. He was not wearing insulated gloves as he handled the wires and made the connections. At the same time, the decedent was ready for breaker to the lighting service panel to be turned on and instructed the foreman to throw the breaker to the “on” position. The foreman, thinking he should throw all three breakers to the “on” position, walked over to the breaker panel, removed his lockout/tagout on all three breakers and proceeded to throw all three to the “on” position. This sent electricity through the wires into the lead electrician’s hand, killing him.

Recommendation No. 1: Employees should always follow company lockout/tagout procedures.

The company had lockout/tagout procedures in place that were to be used in these types of situations. All employees were equipped with lockout/tagout equipment, but because they were the only workers at the facility, only the foreman used his. Normally, all employees that could be adversely effected by the electrical equipment would have locked out the breaker panel. The occupational safety and health regulation 1926.416(a)(1) states that “No employer shall permit an employee to work in such proximity to any part of an electric power circuit that the employee could contact the electric power circuit in the course of work, unless the employee is protected against electric shock by deenergizing the circuit and grounding it or by guarding it effectively by insulation or other means”. The job foreman had used his lockout/tagout but the decedent and the other worker in the junction box had not put their lockout/tagouts on the breaker. This was done to save time. All three men should have removed their lockout/tagouts from the breaker. The two men in the junction box needed to lower themselves to the ground, walk to the breakers and with the foreman, all three electricians then remove their lockout/tagouts so that the correct

Recommendation No. 2: Communication between workers should be clear and precise.

Communication between workers should be clear and precise when instructing other workers on what they want the other workers to do. “Throw the breaker” could mean anything. The men involved in this incident had worked together for several years and knew each other but still miscommunicated. Only the person performing the work should throw the breaker when the work is completed. In this case, the lead electrician should have been the one to throw the breaker in the “on” position after completing the work.
