Occupational Fatality Report

Kentucky FACE Program

Report No. 15KY063

Semi-Truck Owner-Operator Crushed by 7.6 Ton Steel Coil While Securing Load to Flatbed Trailer

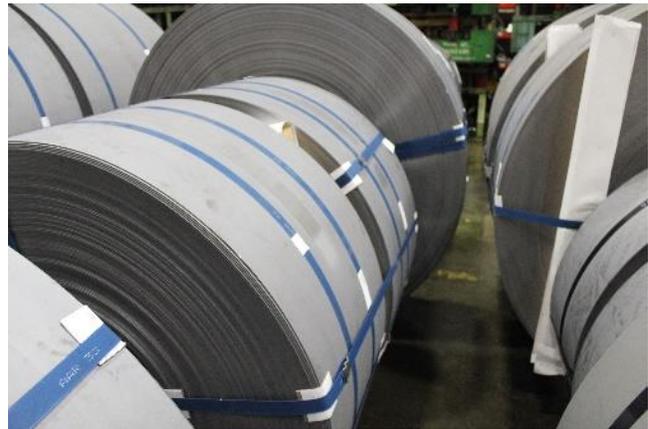
Figure 1. Photo of steel coils at the jobsite.

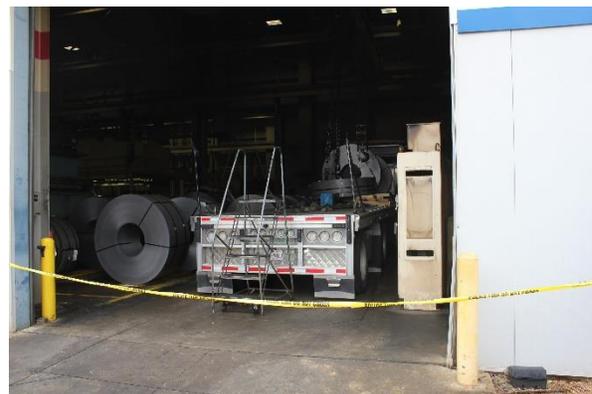
Figure 2. Loading area where incident occurred.

Arriving to the warehouse (Figure 2) at 8:00 am, the truck driver parked his trailer in the loading dock, exited his cab, and greeted the crane operator. The flatbed trailer had arrived with five steel coils that were standing upright and were secured with chains and ratchet straps (Figure 7A). Each coil had a footprint measuring 17.32 inches wide, weighed 7.6 tons, and rested on two 4"x4" hardwood posts.

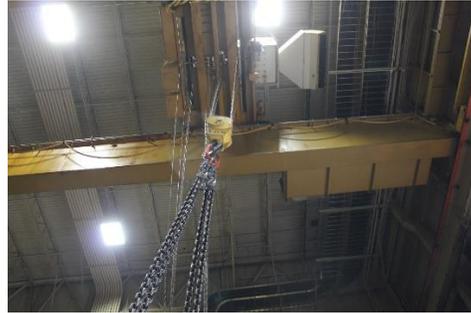
Figure 3. Bridge crane on site.

The truck driver, who had made deliveries in the past to this same location, secured and unsecured the steel coils as they were loaded and unloaded from the flatbed trailer. Using a 40 ton bridge crane (Figure 3), the crane operator moved the steel coils onto and off of the trailer (Figure 6). The bridge crane was operated by a remote control which was mounted to the end of a power cord and hung laterally from the ceiling; this allowed mobility for the bridge crane operator when using the crane.

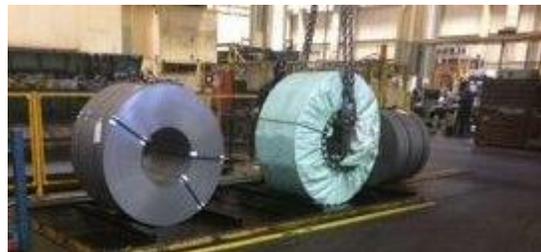
Figure 5. Steel coils in the loading area secured to the bridge crane sling.

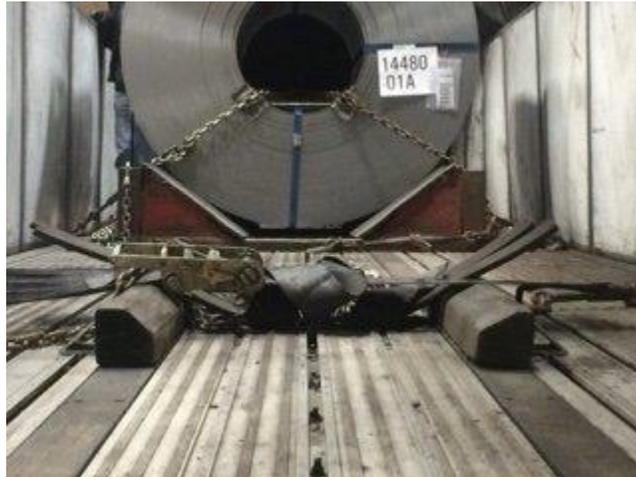
Figure 6. The flatbed trailer where the coils were to be loaded.

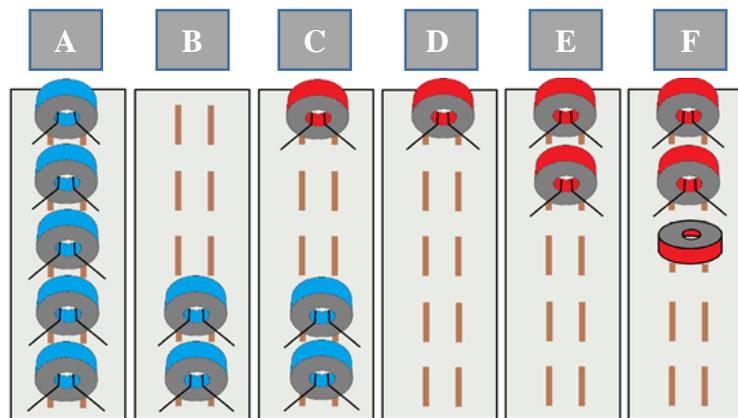
The truck driver and the bridge crane operator removed three of the five steel coils (Figure 7B) before loading the first of the 3 coils that were to be shipped out (Figure 7C). Next, the crane operator used the bridge crane to remove the remaining two coils from the flatbed trailer that were to be delivered (Figure 7D) before proceeding to load the second steel coil to be shipped

Figure 7. The sequence in which the steel coils were loaded and unloaded from the flatbed trailer. The blue coils represent the coils that were to be delivered. The red coils represent the coils that were to be picked up.

out (Figure 7E). The crane operator loaded the third and final coil to be shipped out onto the flatbed trailer, approximately 6 feet from the second coil. The truck driver stood with his back to the crane as he secured the adjacent coil while the crane operator disconnected the sling from the final coil. Though the sling's loop had been disconnected from the final coil, a portion of the sling was still inside the coil's eye.

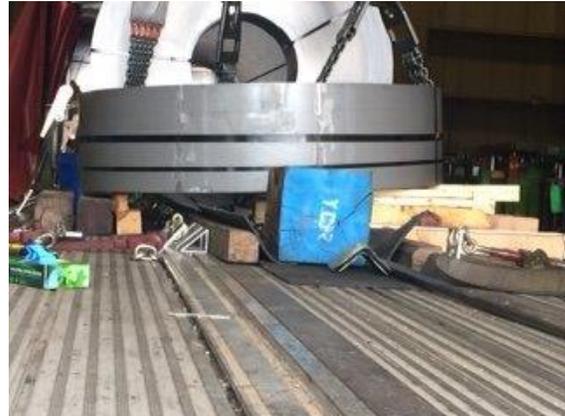
The crane operator turned away from the coils and crane and proceeded to exit the bed of the trailer. As he exited the truck bed, he actuated the controls of the crane to move it up and away from the coil. Moving vertically, the crane began drawing the sling through the center opening of coil. Suddenly the crane operator heard a noise and turned to see what happened. The sling, though disconnected, had become snagged in part of the coil's eye, and the upward motion caused the coil to topple over onto the truck driver (Figure 8). The crane operator immediately radioed for the company's internal emergency response team to report to his area. The response team arrived to find the truck driver pinned face down on the bed of the truck by the 7.6 ton steel coil. The coil struck the truck driver across his posterior thoracic area, coming to rest on his lower lumbar region and legs (Figure 9).

Figure 8. Steel coil that fell on and crushed truck driver, on flatbed trailer.

The steel coil had been set in place and detached from the crane's sling without first being properly secured to the trailer bed. As the crane operator actuated the bridge crane to move away from the coil, the crane's sling became hung in the eye of the coil, causing it to become unstable and fall over onto the truck driver. Had the coil been properly secured to the flatbed trailer prior to removing the crane's sling, the coil may not have become unstable. As a safety precaution, the crane's sling should have been used to hold the coil in place until it was secured to the flatbed trailer.

The sling used to attach the bridge crane to the steel coils was detached from the steel coil, but still left in the coil's eye. As the crane operator actuated the controls of the crane, the sling became caught inside of the eye of the coil, causing the coil to become unstable and topple over. Crane operators should ensure that slings and other means of attachment are free of the crane's eye prior to actuating the crane's controls.

Recommendation No. 1: Steel coils and other cargo that could tip over should be properly secured to the trailer bed prior to detachment from bridge cranes.

Recommendation No. 4: After placing and securing the steel coil in the intended location, authorized loading zone personnel should ensure that slings and other attachments are free of the coil's eye before actuating the crane away from the coil.

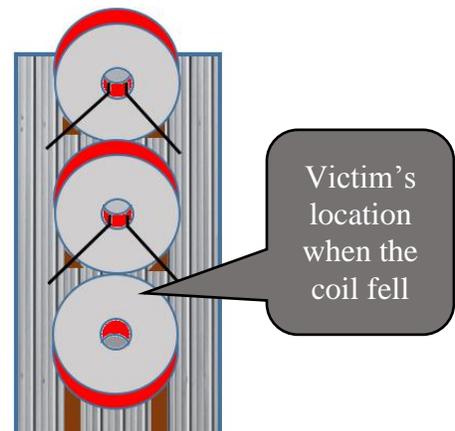
Figure 9. Depiction of steel coil that fell on and crushed truck driver, on flatbed trailer.
