Semi-Truck Owner-Operator Crushed by 7.6 Ton Steel Coil While Securing Load to Flatbed Trailer

CASE SUMMARY

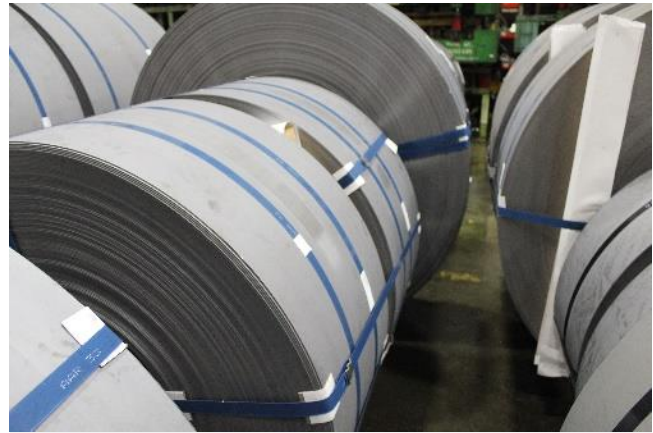
Figure 1. Photo of steel coils at the jobsite.

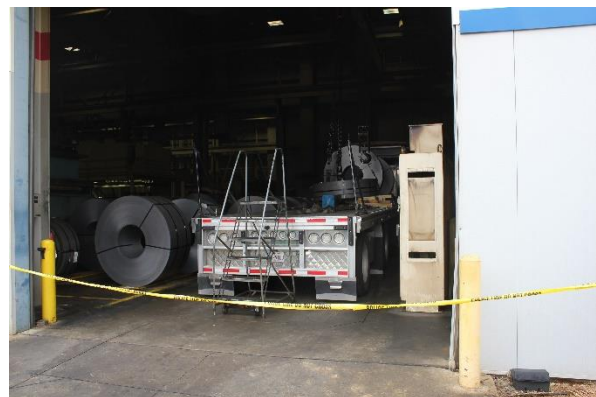
Figure 2. Loading area where incident occurred.

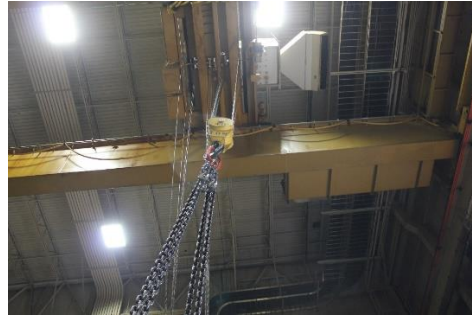
Figure 3. Bridge crane on site.

The truck driver, who had made deliveries in the past to this same location, secured and unsecured the steel coils as they were loaded and unloaded from the flatbed trailer. Using a 40 ton bridge crane (Figure 3), the crane operator moved the steel coils onto and off of the trailer (Figure 6). The bridge crane was operated by a remote control which was mounted to the end of a power cord and hung laterally from the ceiling; this allowed mobility for the bridge crane operator when using the crane.

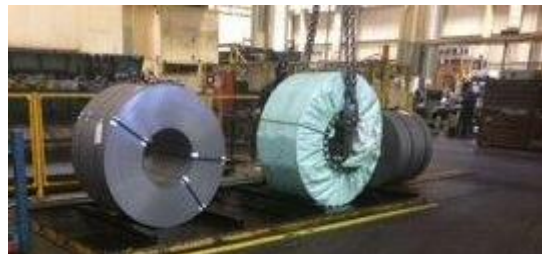
Figure 5. Steel coils in the loading area secured to the bridge crane sling.

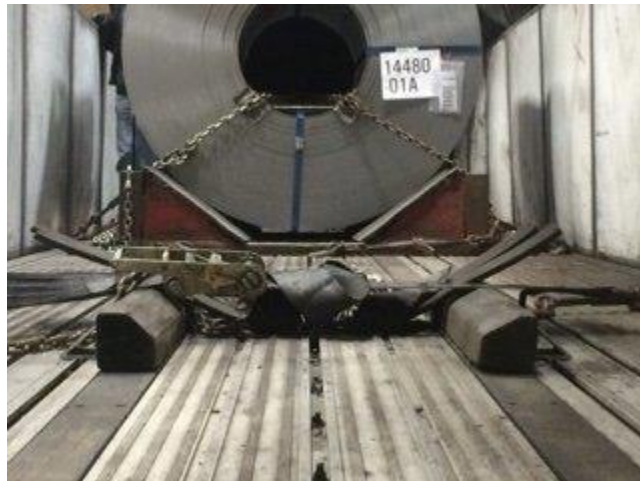
Figure 6. The flatbed trailer where the coils were to be loaded.

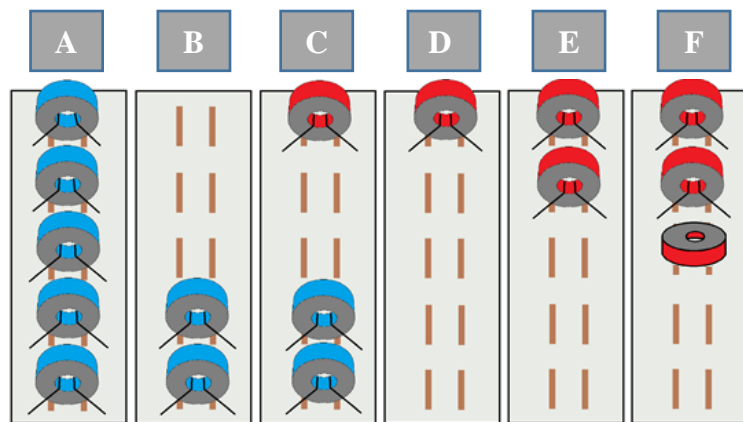
Arriving to the warehouse (Figure 2) at 8:00 am, the truck driver parked his trailer in the loading dock, exited his cab, and greeted the crane operator. The flatbed trailer had arrived with five steel coils that were standing upright and were secured with chains and ratchet straps (Figure 7A). Each coil had a footprint measuring 17.32 inches wide, weighed 7.6

tons, and rested on two 4"x4" hardwood posts. The truck driver and the bridge crane operator removed three of the five steel coils (Figure 7B) before loading the first of the 3 coils that were to be shipped out (Figure 7C). Next, the crane operator used the bridge crane to remove the remaining two coils from the flatbed trailer that were to be delivered (Figure 7D) before proceeding to load the second steel coil to be shipped

Figure 7. The sequence in which the steel coils were loaded and unloaded from the flatbed trailer. The blue coils represent the coils that were to be delivered. The red coils represent the coils that were to be picked up.

out (Figure 7E). The crane operator loaded the third and final coil to be shipped out onto the flatbed trailer, approximately 6 feet from the second coil. The truck driver stood with his back to the crane as he secured the adjacent coil while the crane operator disconnected the sling from the final coil. Though the sling's loop had been disconnected from the final coil, a portion of the sling was still inside the coil's eye.

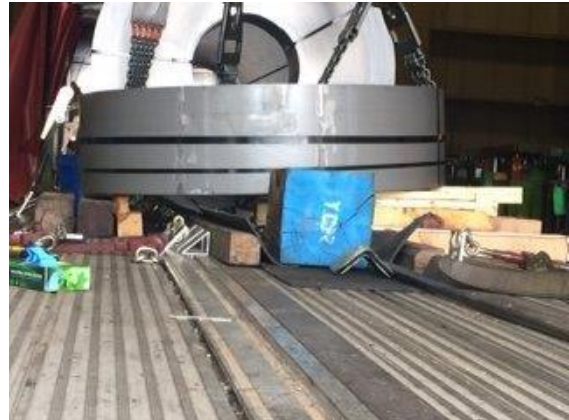
The crane operator turned away from the coils and crane and proceeded to exit the bed of the trailer. As he exited the truck bed, he actuated the controls of the crane to move it up and away from the coil. Moving vertically, the crane began drawing the sling through the center opening of coil. Suddenly the crane operator heard a noise and turned to see what happened. The sling, though disconnected, had become snagged in part of the coil's eye, and the upward motion caused the coil to topple over onto the truck driver (Figure 8). The crane operator immediately radioed for the company's internal emergency response team to report to his area. The response team arrived to find the truck driver pinned face down on the bed of the truck by the 7.6 ton steel coil. The coil struck the truck driver across his posterior thoracic area, coming to rest on his lower lumbar region and legs (Figure 9).

Figure 8. Steel coil that fell on and crushed truck driver, on flatbed trailer.

The steel coil had been set in place and detached from the crane's sling without first being properly secured to the trailer bed. As the crane operator actuated the bridge crane to move away from the coil, the crane's sling became hung in the eye of the coil, causing it to become unstable and fall over onto the truck driver. Had the coil been properly secured to the flatbed trailer prior to removing the crane's sling, the coil may not have become unstable. As a safety precaution, the crane's sling should have been used to hold the coil in place until it was secured to the flatbed trailer.

The sling used to attach the bridge crane to the steel coils was detached from the steel coil, but still left in the coil’s eye. As the crane operator actuated the controls of the crane, the sling became caught inside of the eye of the coil, causing the coil to become unstable and topple over. Crane operators should ensure that slings and other means of attachment are free of the crane’s eye prior to actuating the crane’s controls.

Recommendation No. 1: Steel coils and other cargo that could tip over should be properly secured to the trailer bed prior to detachment from bridge cranes.

Recommendation No. 4: After placing and securing the steel coil in the intended location, authorized loading zone personnel should ensure that slings and other attachments are free of the coil’s eye before actuating the crane away from the coil.

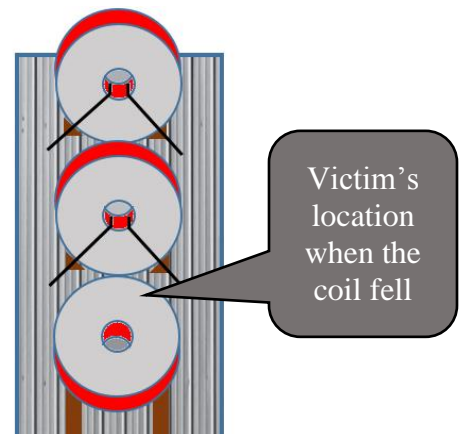
Figure 9. Depiction of steel coil that fell on and crushed truck driver, on flatbed trailer.
