## Cell Tower Technician Dies after Antenna Array Falls and Decapitates Him

### Case Summary

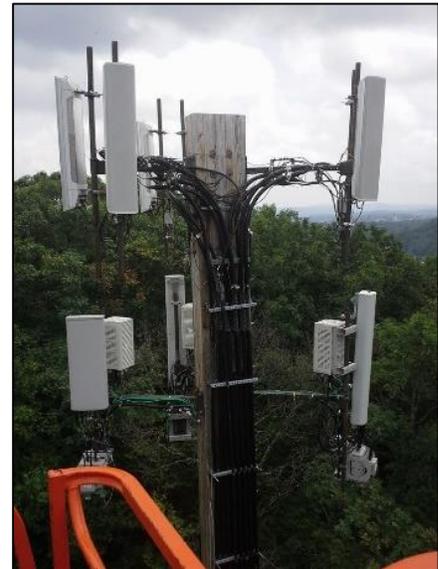
On July 2, 2014, at approximately 2:15 pm, a 28-year-old tower technician and father of three was 242 feet in the air on a cellular tower performing maintenance. His task was to upgrade and replace 3 antenna arrays or “booms” that weighed approximately 1800 lbs. each. The victim was on the load-bearing side of the tower while another employee was on the opposite side, 25 feet below the victim. The crew had already replaced 2 of the 3 antenna arrays and was in the process of setting the third in its place, when they heard a loud pop. The antenna array was 15 feet above the victim on a McKissick “Snatch Block” pulley, Model 419.

The supporting shackle suffered a catastrophic failure causing the cable to snap. The antenna array crashed down striking three points on the tower, then the cables amputated the victim’s head, and right arm. The employee on the opposite side immediately radioed the ground crew and reported the victim’s demise. The ground crew called 911, at 2:22 pm, to report the fatality and ask for assistance in lowering the victim to the ground. They also requested power shut-off for an energized electric line contacting the broken cables. Emergency crews arrived on the scene, minutes later, to begin the tedious process of lowering the victim to the ground.

**Recommendation No. 1: Employers should ensure that a competent rigger is on site to perform a site hazard assessment before work is performed.**

**Recommendation No. 2: Employers should ensure that all tower technicians are competent and trained on proper equipment use, procedures, and how to safely do their jobs.**

**Recommendation No. 3: Employers should ensure that regular inspection of required antenna replacement equipment is performed before initiating work.**

**Recommendation No. 4: Cell tower employers should ensure that antenna replacement equipment is used properly and according to manufacturers’ recommendations.**
