## Construction Laborer Killed in Trench Collapse While Taking Grade Measurements

### CASE SUMMARY

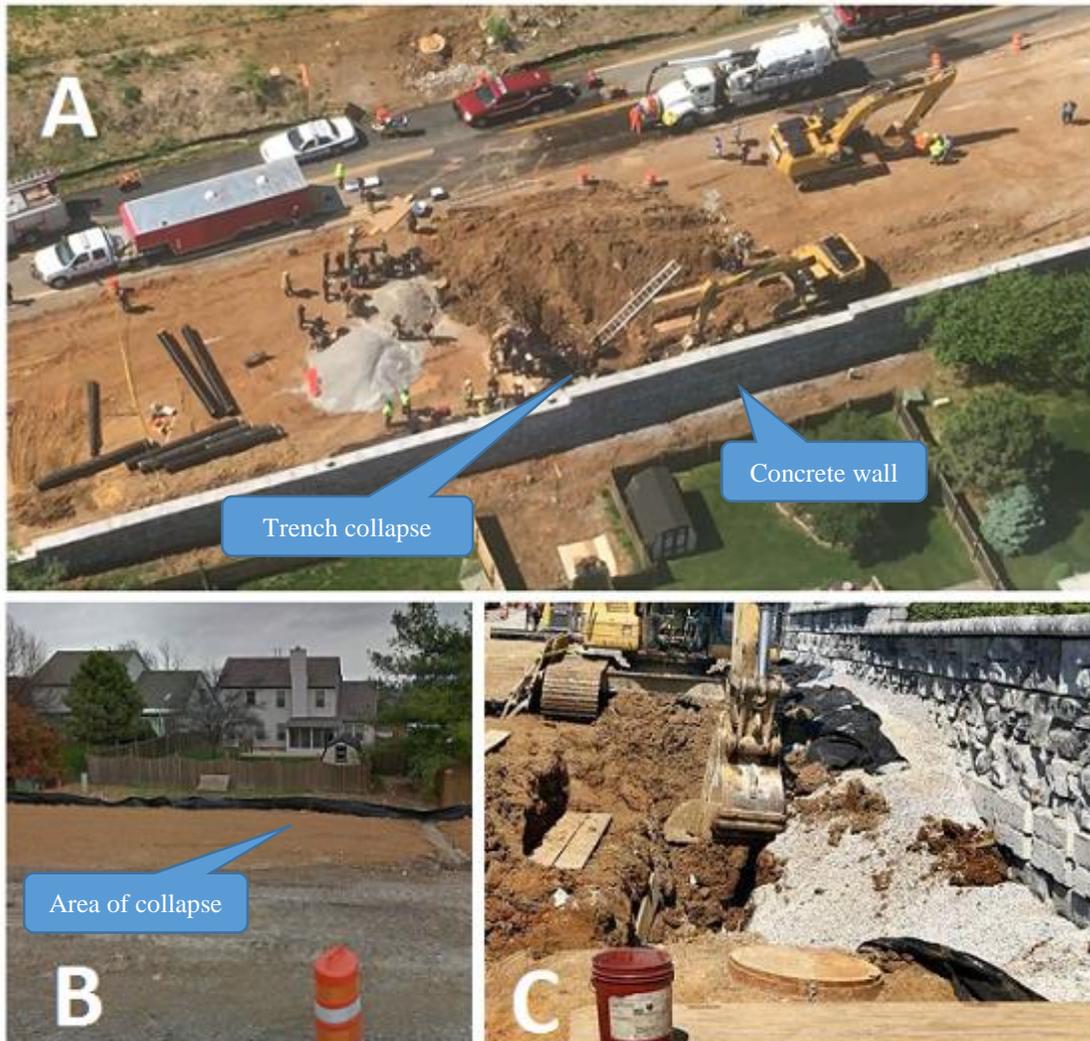
**Figure 1.** A) Aerial view of incident scene, B) photo of trench collapse location 4 months prior to incident, C) section of trench that collapsed on victim; concrete wall.

The incident took place along a two-lane highway construction site where the two-lane highway was being widened. Running parallel at a distance of 45-50 feet from the road was a concrete wall that had been recently erected to separate the widened road from an adjacent residential neighborhood (Figure 1A). In preparation for a sewage pipeline to be laid, a trench measuring approximately 13.4 feet deep was being excavated parallel to the concrete wall (Figure 1C). The distance between the section of the trench that collapsed and the concrete wall was estimated to be approximately 4-5 feet.

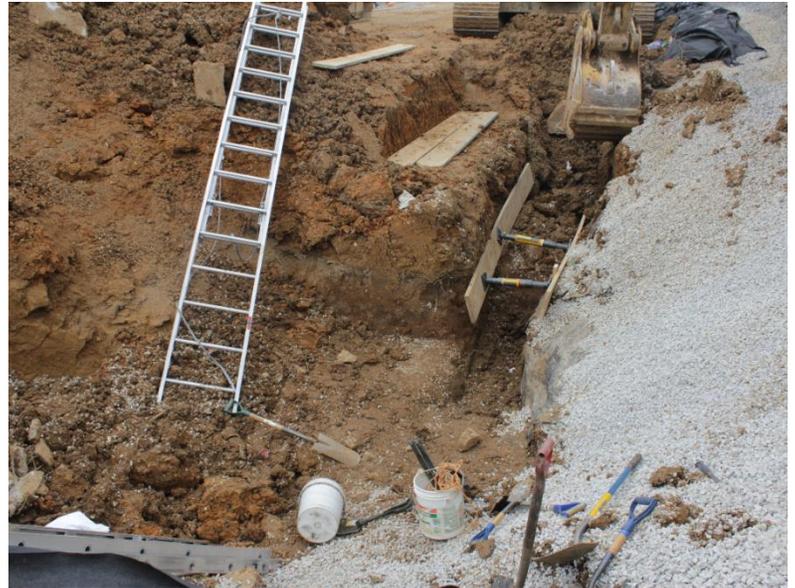
The soil along the concrete wall facing the side of the trench was a mixture of class B and class C soil, along with #57 gravel backfilled along the wall foundation (figure 2). The soil surrounding the base of the concrete wall had previously been disturbed during the wall's construction. The spoil pile was placed on the road-facing side of the trench at the required 2 foot minimum distance, however, this was still unsafe due to the pile's size and the lack of a trench protection system.

**Figure 2.** View looking down at the trench containing a mixture of class B and C soils on the right side of the trench near the concrete wall. Class B soil is observed on the opposite side of the trench.

Performance of a soil test and an adequate trench protective system could have prevented this incident. OSHA requires that all workers in trenches 5 feet or more in depth be protected by sloping, shoring, or the use of shields. Since the soil was a mixture of class B and C soils, the soil should have been classified as class C soil. Trench excavation with class C soil requires sloping at 1½ H:1V (or 34°), meaning that the soil needed to be cut back 1½ ft. for every 1 ft. of depth (Figure 5). Given the proximity of the trench to the concrete wall, it was impossible to achieve the necessary slope on both sides of the trench. Since the concrete wall made conventional sloping techniques impossible, a trench box or shoring system should have been installed prior to allowing entry into the trench.

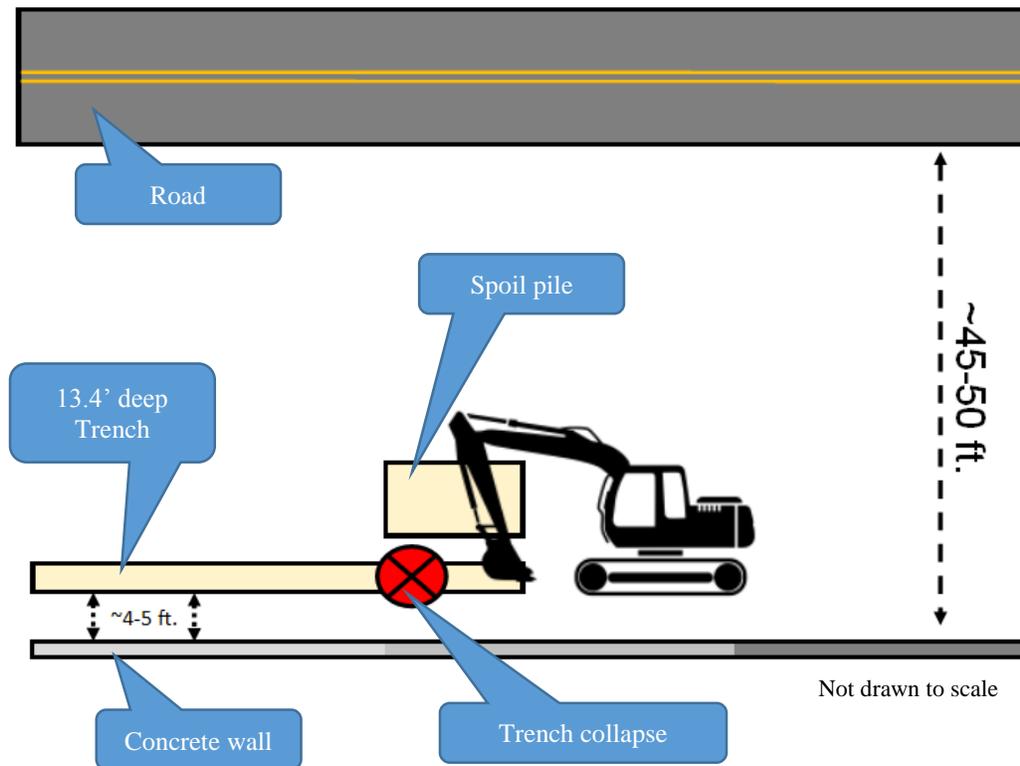
**Figure 3.** Diagram of incident scene.

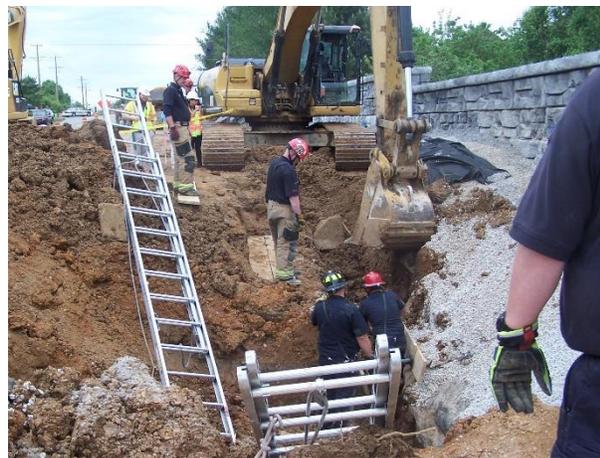
**Figure 4.** Trench collapse special response unit attempting to recover the victim.

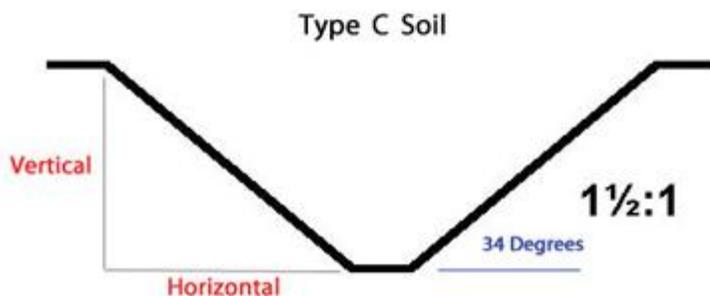
The excavation operator commented that he was to bench the road-facing side of the trench. However, OSHA requires that type C soil be *sloped and never benched*. Furthermore, sloping and benching techniques must be applied to both sides of the trench to be effective. The side of the trench facing the concrete wall was the side that was most unstable and suffered the fatal collapse.

**Figure 5.** OSHA sloping requirements for type C soil. This method would not have been possible due to the proximity of the trench to the concrete wall.

OSHA Sloping Requirements		
Soil Type	Slope	Angle (degrees)
A	3/4H:1V	53°
B	1H:1V	45°
C	1½H:1V	34°

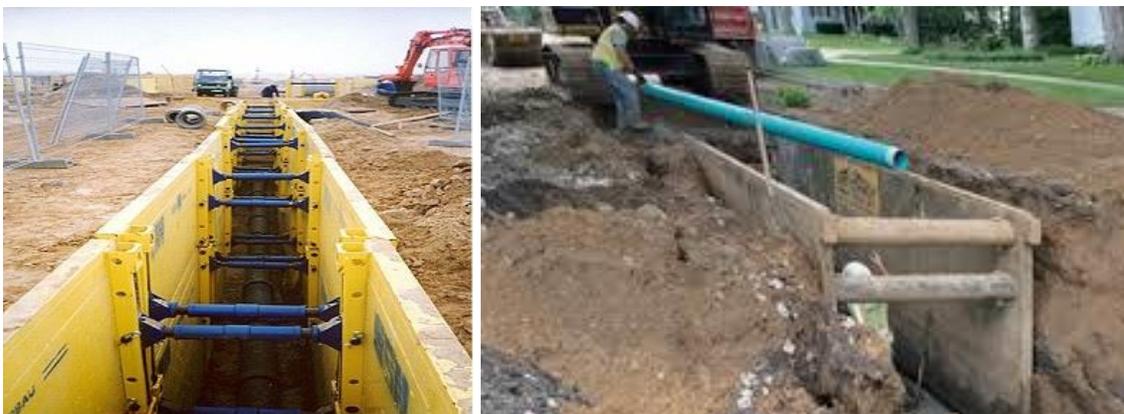
**Figure 6.** Stock photos of trench shoring (left), trench box (right).

Employees working in trenches of five feet or more in depth should be protected from cave-ins by adequate protection systems appropriate for the conditions in the trench, including sloping or benching techniques, shoring, or shields (trench boxes).<sup>1</sup> Sloping involves making sure that the soil is at an angle to prevent the soil from caving into the trench. In this particular incident, sloping was not a viable option due to the proximity of the trench to the adjacent concrete wall. When sloping methods are not feasible, trench shields or aluminum hydraulic shoring systems should be used. In addition to the use of correct protective systems, the spoil pile should also be at least two feet from the edge of the trench.

When installing miles of pipeline or cable, the amount of soil that must be moved along with the associated cost of excavator fuel, operator time, backfill, compaction, etc., can make sloping inefficient and time consuming in regard to project deadlines. Rather than foregoing the use of a protective system altogether, it is strongly recommended that employers at least require trench shields or aluminum hydraulic shoring systems, both of which are OSHA-approved protective systems that can be rented, if needed. These protective systems can still adequately protect workers while increasing project expediency and efficiency.
