REPORT#: 18KY007

REPORT DATE: 11-5-18

Police Officer Drives into Flood Waters and Drowns

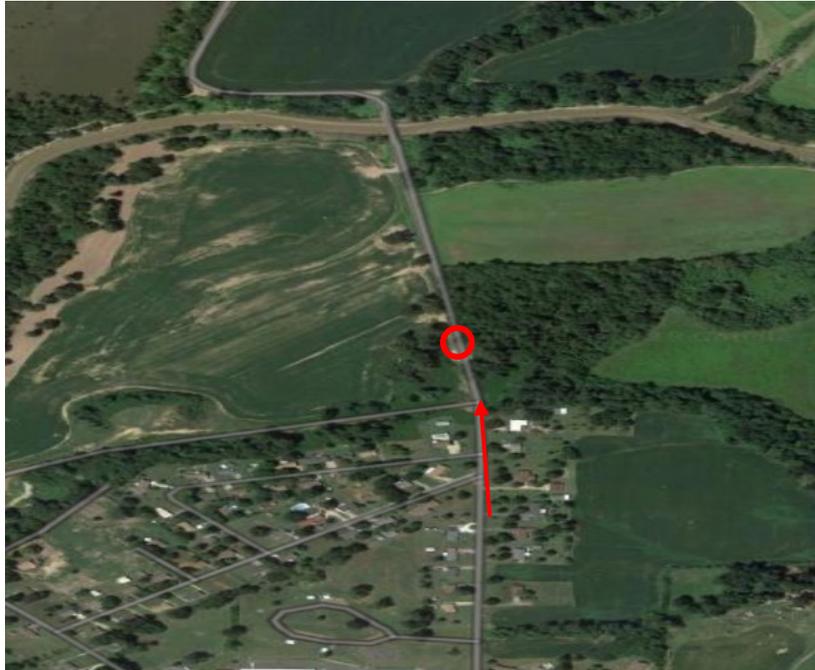
The scene was a roadway at the edge of the city limits within a subdivision with a posted speed limit of 15 mph. Normally, the road travels through a large field for .2 miles before crossing a bridge over a small creek that feeds a major river approximately 1.25 miles to the west. During the rainy season, the creek quickly floods from the overspill of the river. At this particular location, bank-full – which is the height of water at a given location on the river above where an increase in water will cause the river to overflow the lowest stream bank¹ – is 37 feet. At the time of this incident, the river was at a flood stage of 46.86 feet. The record high at this location was 5/2/2011 when the river reached 54.29 feet².

Photo 1. Aerial photo of the scene with creek at normal levels. Arrow indicates direction of travel; circle indicates where the vehicle entered the water. Photo courtesy of Google Earth.

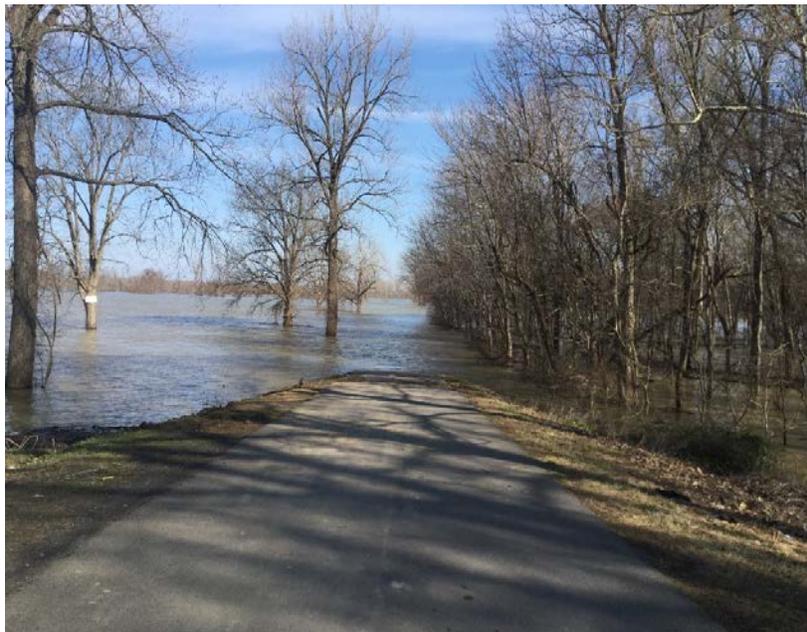
Photo 2. Scene where the victim and his vehicle entered the water.
Photo property of KY FACE.

When interviewed, the police chief stated he was not sure why the victim was in that area since it had been flooded for several days due to heavy rain. The victim had worked the night before the incident from 7:00pm to 7:00am, and the chief felt sure that he was aware of the flooding in that area. When interviewed, the incident commander stated that because it was a Friday night, and because teenagers frequented the street to party, the officer might have been patrolling the area to look for underage drinking. As he travelled on the road, the victim crested a hill and drove approximately 500 feet before his vehicle struck and entered the water. As water submerged the vehicle, it slowly drifted towards the driver's side off the road and into the flooded field. Due to the limited light, it is likely the officer was unaware that the terrain he had entered quickly sloped downwards, creating a pool of water approximately 12-15 feet deep.

Recommendation #1: County road department should install a roadway sign that warns of quick flooding during rain and close the road as quickly as possible with temporary barricades.

Discussion: When questioned why there were no barriers to prevent vehicles from accessing the area, the chief of police stated the reason was that boaters would use the natural downward slope of the road to launch their boats into the water while the road was flooded, since the permanent dock for launching was under water and inaccessible. At the time of the incident, the only signage warning drivers of floodwaters was a permanent sign stating “Water Over Roadway”; however, since the sign was permanent and not removed during the dry season, it may have been easy for drivers to become complacent and ignore the sign. After the incident, two orange barrels holding a removable sign stating “Road Closed” was placed on the road blocking access to the water. The sign, however, was small and lightweight, and a driver could easily move the sign in order to obtain access to the water. To prevent all vehicles from entering the flooded area, the county road department should consider installing a roadway sign that warns of quick flooding during heavy rains and close the road as quickly as possible with temporary barricades when the road becomes impassible.

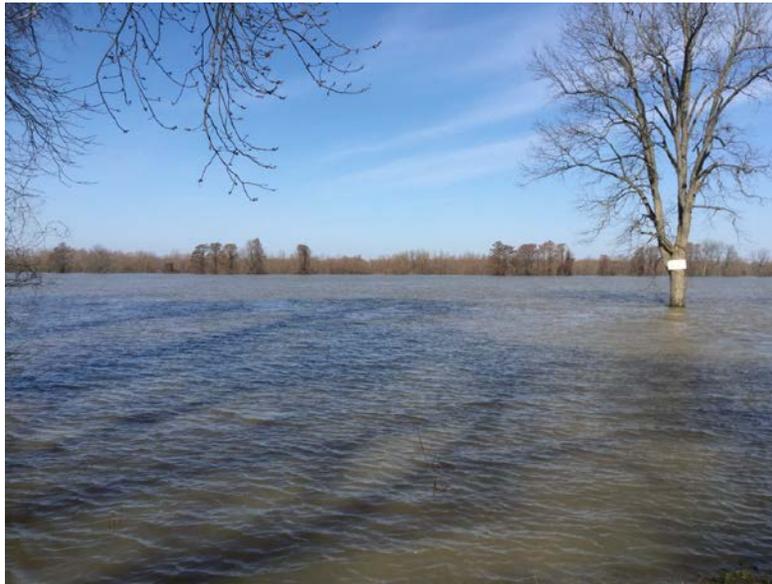
Photo 3. The flooded field from which the victim and his vehicle were retrieved. Search and rescue divers located both approximately 150 yards northwest of the marked tree. Photo property of KY FACE.

Additional officers, as well as the Fish and Wildlife rescue dive team were on-site by 9:24 pm, and at 9:33 pm, incident command was established. The Fish and Wildlife dive team entered the water and discovered the vehicle approximately 150-200 yards from where it had entered the water. The vehicle was discovered on its side before swift waters rolled the vehicle onto its top. Due to strong underwater currents, the rescue diver could only dive to a depth of 12 feet at the time, making it difficult to locate the victim. In order to locate the victim, the dive team had to drag the surrounding area. The dive team worked through the night in an attempt to recover the victim. At 5:10 am, the officer was located and brought to shore where the coroner on the scene pronounced him dead.

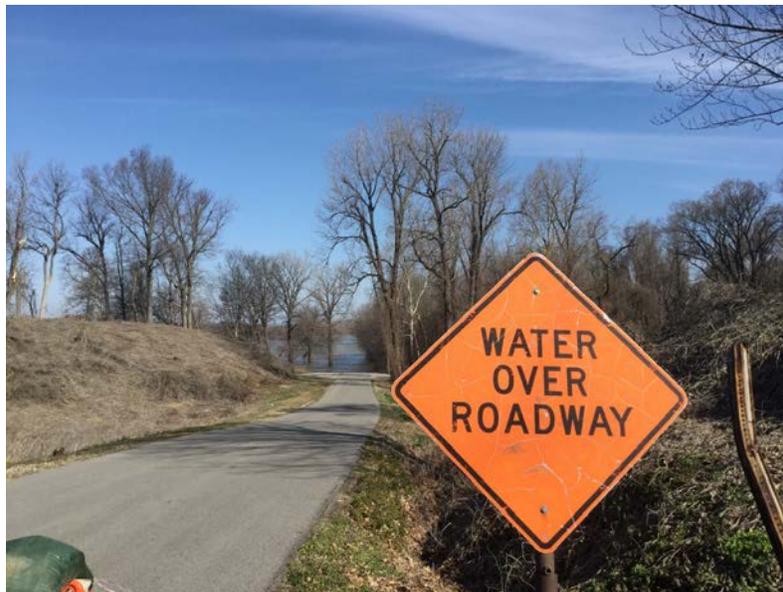
Photo 4. Permanent ‘Water Over Roadway’ sign.
Photo property of KY FACE.

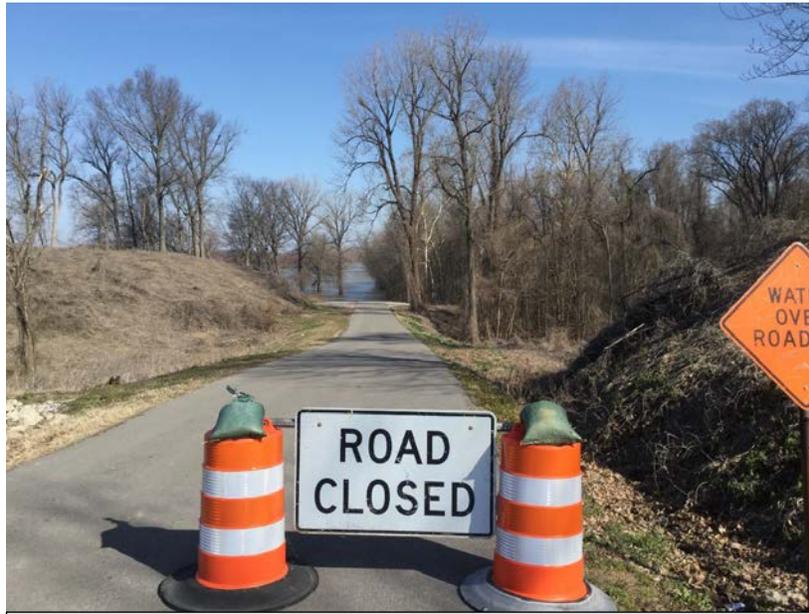
Photo 5. 'Road Closed' sign and barrels added post-incident.
Photo property of KY FACE.
