REPORT#: 18KY054

REPORT DATE: 1-16-2019

Teen Roofer Electrocuted when Ladder Contacts High Voltage Power Line

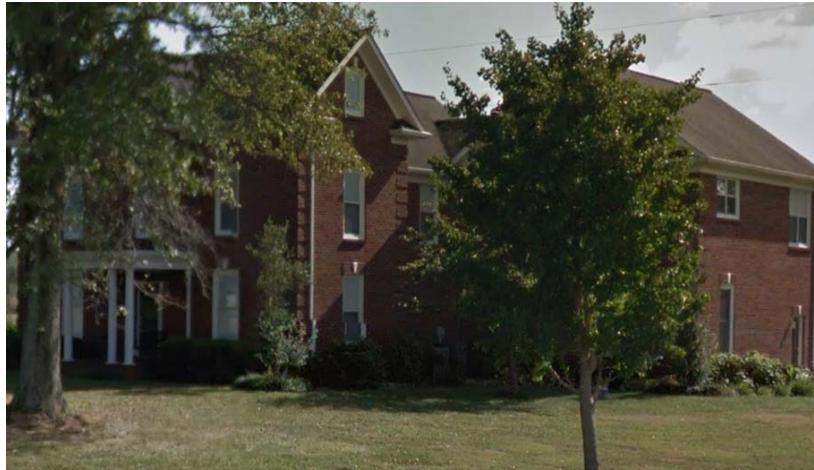
The incident scene was a single family, private residence located on a rural highway, 3.5 miles from the nearest town. The two-story brick home measured 4,022 square feet and sat on a 57-acre parcel of land. On the home's exterior was a 600 square foot garage and several decorative boxwood shrubs that circled the perimeter of the house.

Image 1. Residence the victim was working on at the time of the incident.
Photo property of KY FACE.

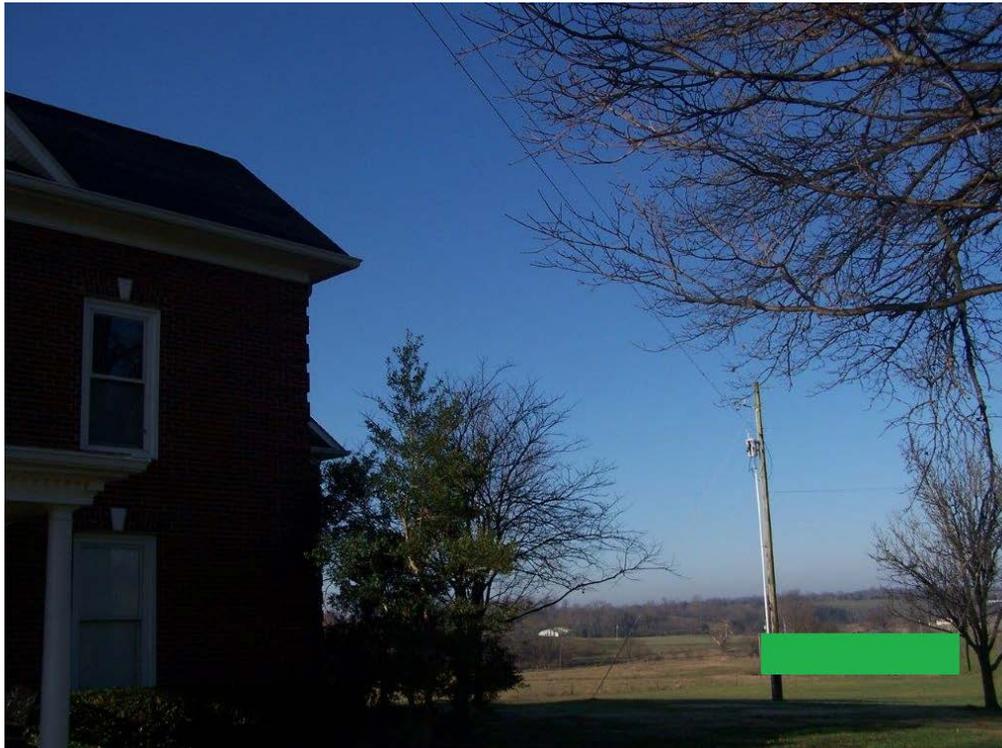
At approximately 12:00 pm, the victim gathered a model D1828-2EQ Werner aluminum extension ladder and moved to the front of the house to begin work there while the other three men moved on to the side of the house. At the front of the house, there were two 4 feet x 4 feet boxwood bushes planted 3 feet from the home's exterior wall at the point where the victim was attempting to access the roof. There were no witnesses, but it is believed that because of the bushes, the victim was having trouble accessing the roof. With the ladder still fully extended, the victim attempted to move it closer by lifting the ladder and walking between the bushes to find a suitable base. The ladder became unstable, causing the victim to lose his balance falling backwards. As the victim and ladder were falling, the ladder fell into a top phase power line carrying 7.2 kilovolts (7,200 volts). Because the victim was still in contact with the highly conductive aluminum ladder when it struck the power line, electricity was able to travel through the metal and into the young worker. He was immediately electrocuted.

Photo 2. Front of the residence and power line that employee contacted with ladder.
Photo property of KY FACE Program.

In instances where an extension ladder needs to be relocated, employees should lower the extended portion of the ladder until it is appropriately collapsed, carefully lay the ladder down, and transport it horizontally while grasping the ladder's middle section with both hands in order to safely manage its weight. Once the ladder is placed in the necessary area, ensure the base is secure and re-extend the ladder to the appropriate height. Had the ladder been lowered and transported horizontally, the high voltage line could have been avoided.

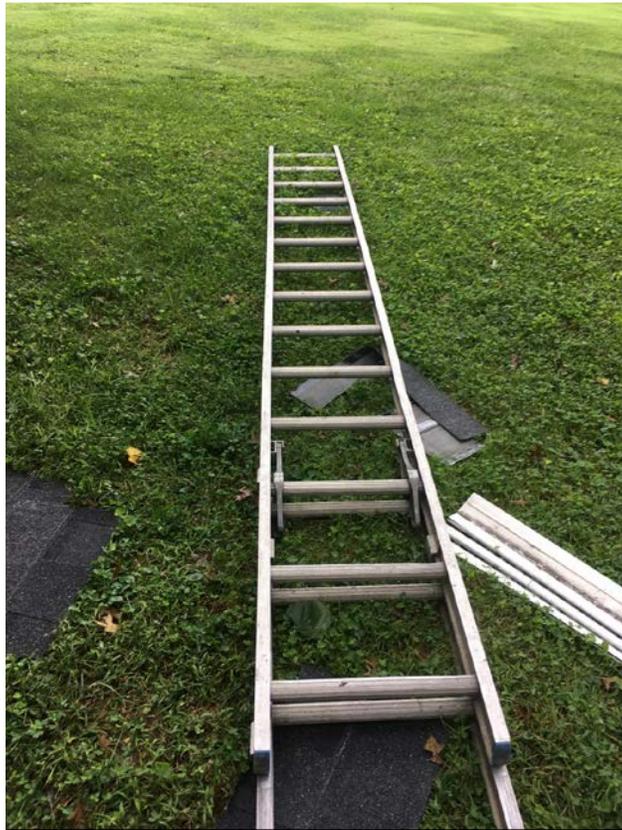
Photo 3. The ladder used by the victim.
Photo property of KY FACE.

Discussion: At the time of the incident, the victim was using an aluminum ladder to access the roof. Aluminum has an electrical resistivity (ρ ($\Omega \cdot m$)) – the measure of how strongly a material opposes the flow of electric current – of 2.82×10^{-8} at 20°C. Inversely, aluminum has an electrical conductivity (σ (S/m)) – the measure of how well a material conducts an electrical current – of 3.5×10^7 at 20°C. Because of its extremely low resistivity and extremely high conductivity, aluminum is one of the best electrical conducting metals, behind only silver, copper, annealed copper, and gold⁶. As the ladder contacted the overhead power line, 7,200 volts and 16 amperes (amps) travelled through ladder, into the victim, and exited his body via the stomach and each foot’s fifth (pinky) toe. At values as low as 100 milliamps (.1 amps), death can occur⁷. Due to the high amount of amperes that entered the victim’s body, cardiac arrest occurred instantly.

In order to prevent similar incidents, the employer should consider using a non-conductive ladder, such as those made of a fiberglass-reinforced polymer, when working around live power lines. Due to its low electrical conductivity and high resistance to corrosion, these ladders would make a safe and practical choice when working outdoors around electricity. However, employers should ensure that these fiberglass ladders are maintained properly as required by 29 CFR 1926.1053. Unmaintained ladders may accumulate excess dirt or moisture that can conduct electricity in the event it encounters a high voltage line.

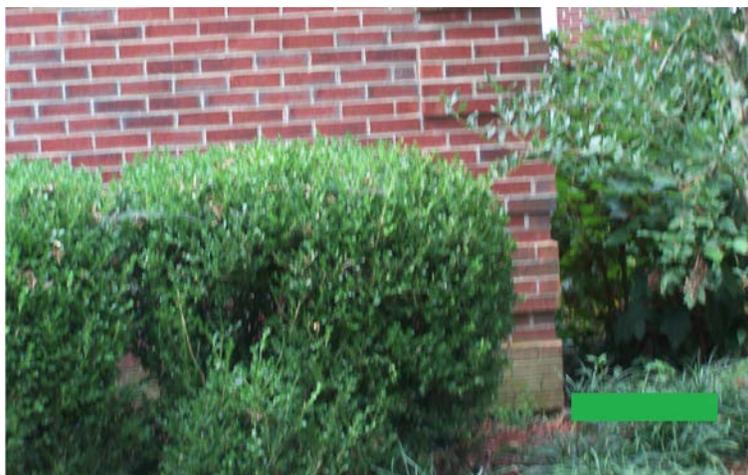
Photo 4. The box wood bush the victim was attempting to work around.
Photo property of KY FACE.

was moving the ladder, which was extended to the maximum length of 25 feet. As the ladder became unstable and began to fall, the victim may have been unable to support the ladder's top-heavy design while standing on uneven terrain, which allowed it to contact the power line.
