ANATOMY OF A FATALITY: KENTUCKY

PERFORMING A TASK WITHOUT THE PROPER EQUIPMENT—EITHER TO COMPLETE THE TASK OR TO PROTECT HIMSELF ON THE JOB—COST THIS SCRAP WORKER HIS LIFE.

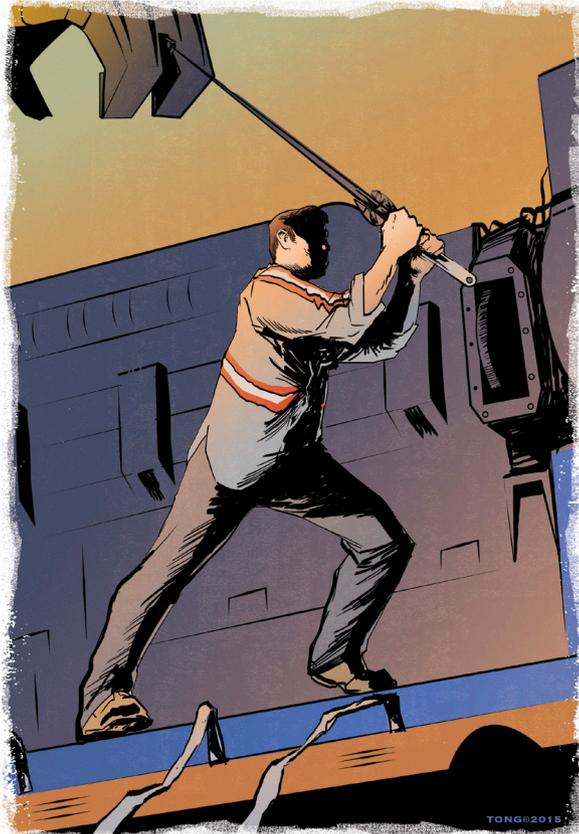
This makeshift torque system worked for 40 bolts. On the 41st, John signaled the excavator operator to apply tension to the sling, then he grabbed the sling and leaned over to have a look at the bolt. Just then, the wrench slipped off the bolt, shot out, and struck him on the right side of his bare head.

Would this injury alone have killed him? Maybe, but maybe not. We'll never know, because after the wrench hit him, he fell 6 feet to the ground. There was no guardrail on the locomotive flywheel where he was working. The workers had already removed it before they started to recover the bolts. John

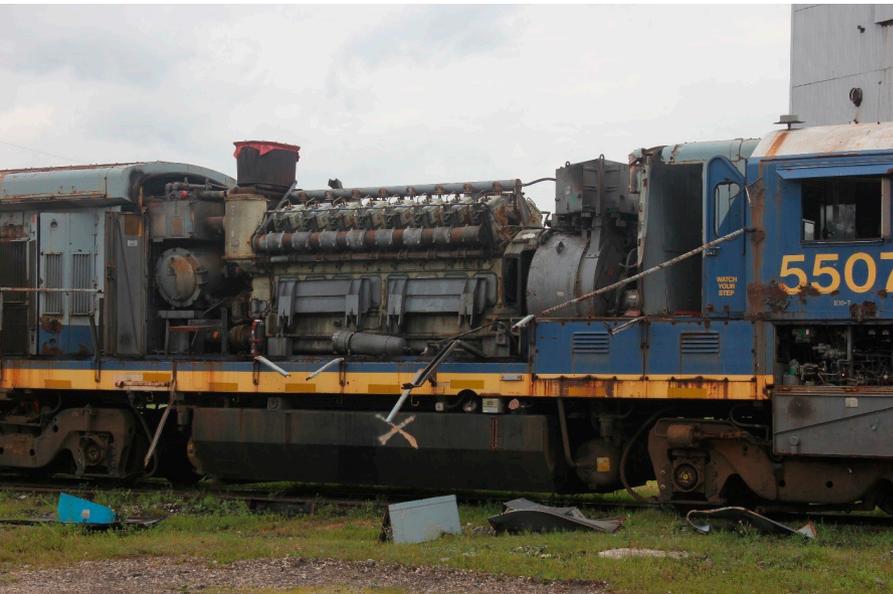
Workers had already removed the guardrail from the locomotive where the victim was working, which could have helped prevent him from falling and striking the pieces of scrap below.

■ Employers should require guarding or ensure that employees use fall protection when they are working 4 feet or more above ground. Prior to the work they were performing at the time of the incident, the workers had removed the guardrail, and they were not using any other form of fall protection while working 6 feet above the ground. Had the railing or fall protection been in place, it could have prevented the victim from falling onto scrap metal pieces that were on the ground, possibly reducing his injuries.

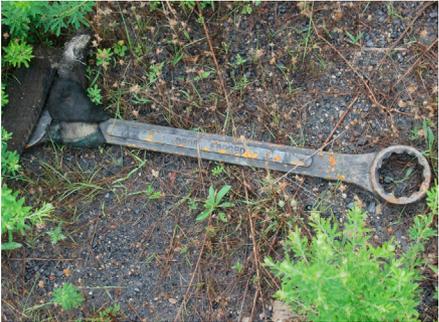
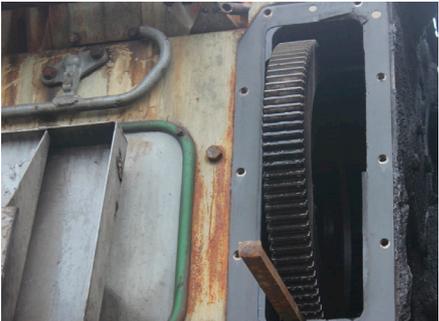
To salvage rusty bolts (above), the workers created a makeshift torque system by attaching a harness to the 48-mm wrench (top) and pulling on it with a grapple attachment on an excavator. This proved to be a dangerous substitute for the hydraulic wrench they needed, investigators reported.

- Employers should ensure employees use appropriate tools for the required job. When the employer instructed workers to salvage the bolts, it should have provided a hydraulic wrench to do so.
