# Grain Truck Driver Killed at Train Crossing

Incident Number: 13KY046

**Kentucky Fatality Assessment and Control Evaluation (FACE) Program  
Incident Number: 13KY046  
Release Date: March 28, 2014  
Subject: Grain Truck Driver Killed at Train Crossing**

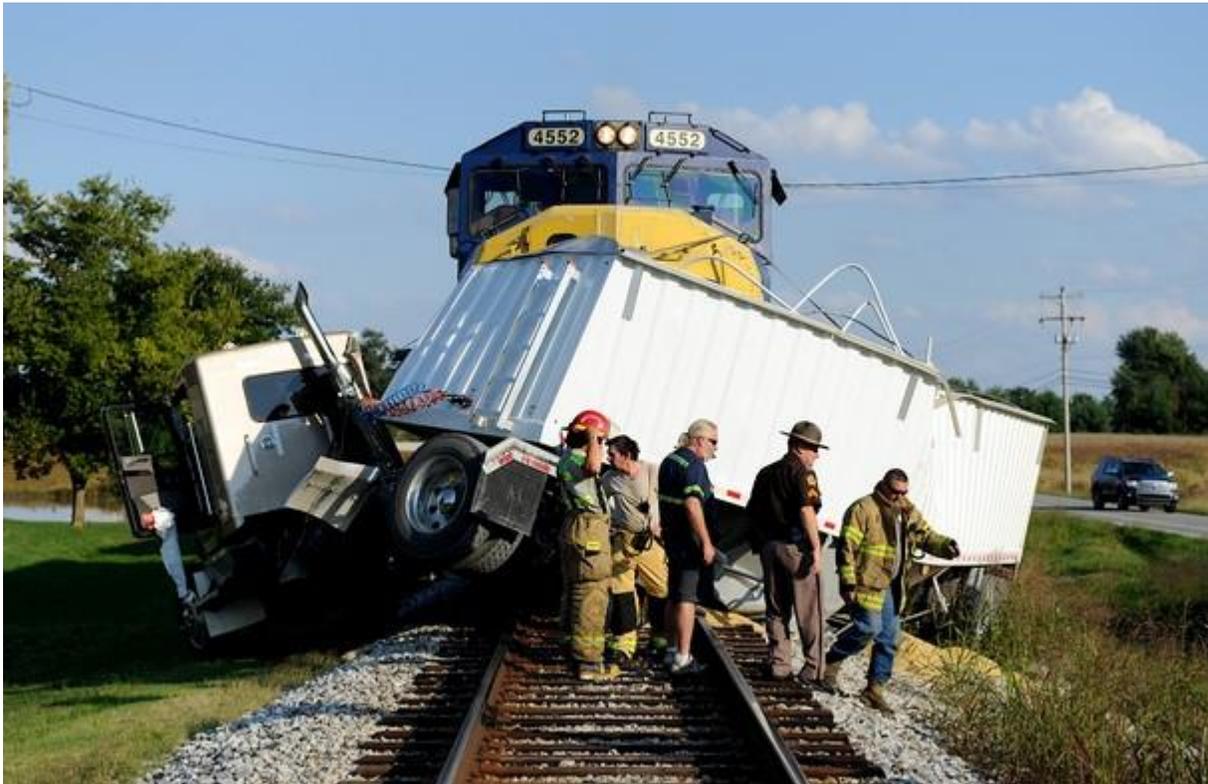
Photograph property of KY FACE Program

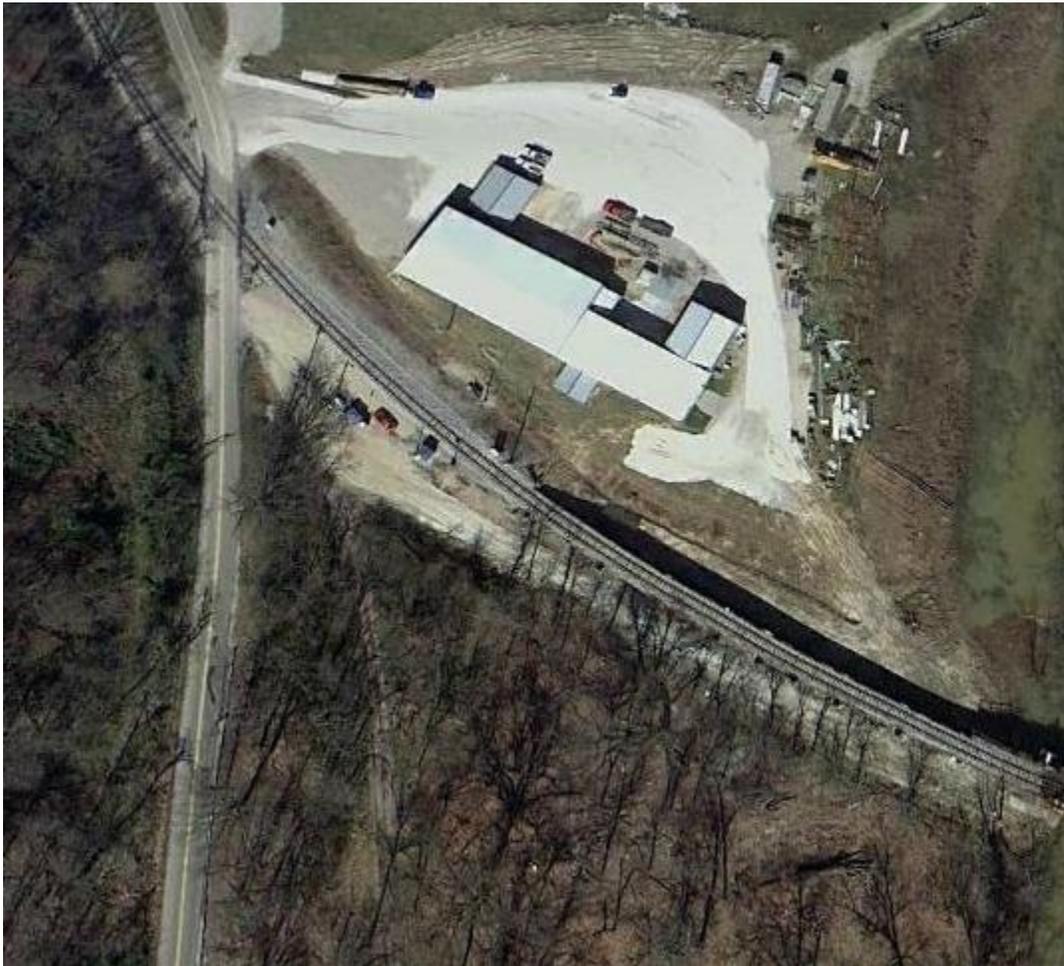
The crossing had warning lights but not guard arms. It's not known if the warning lights were working, but the truck driver did not seem to see the lights or hear the sound of the blowing horn.

Picture provided by Google earth

**Recommendation No. 3: Crossings should be marked and guard arms installed at all crossings.**

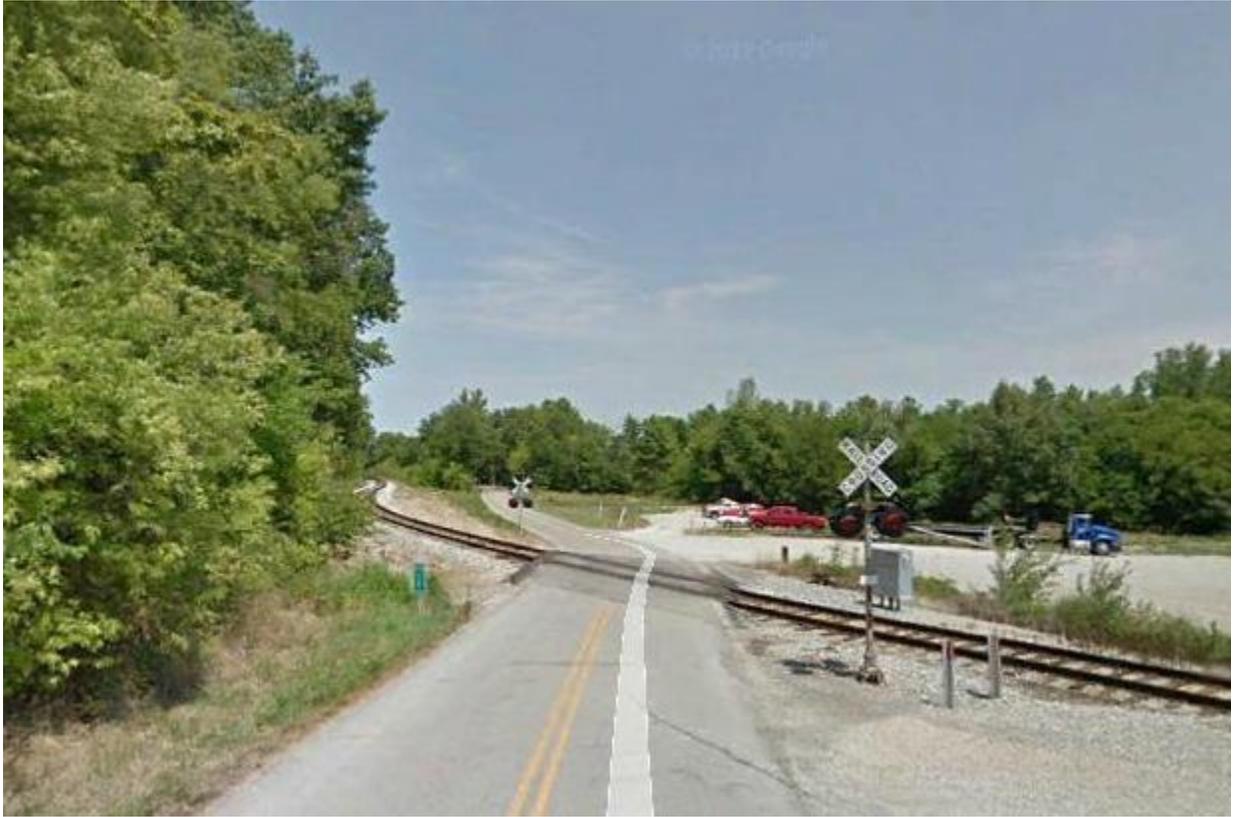
Picture provided by Google earth
