Semi-Truck Team Driver Pinned and Killed while Adjusting Tandems

Incident Number: 14KY064

**Kentucky Fatality Assessment and Control Evaluation (FACE) Program
Incident Number: 14KY064
Release Date: September 2, 2015
Subject: Semi Truck Team Driver Pinned and Killed while Adjusting
Tandems**

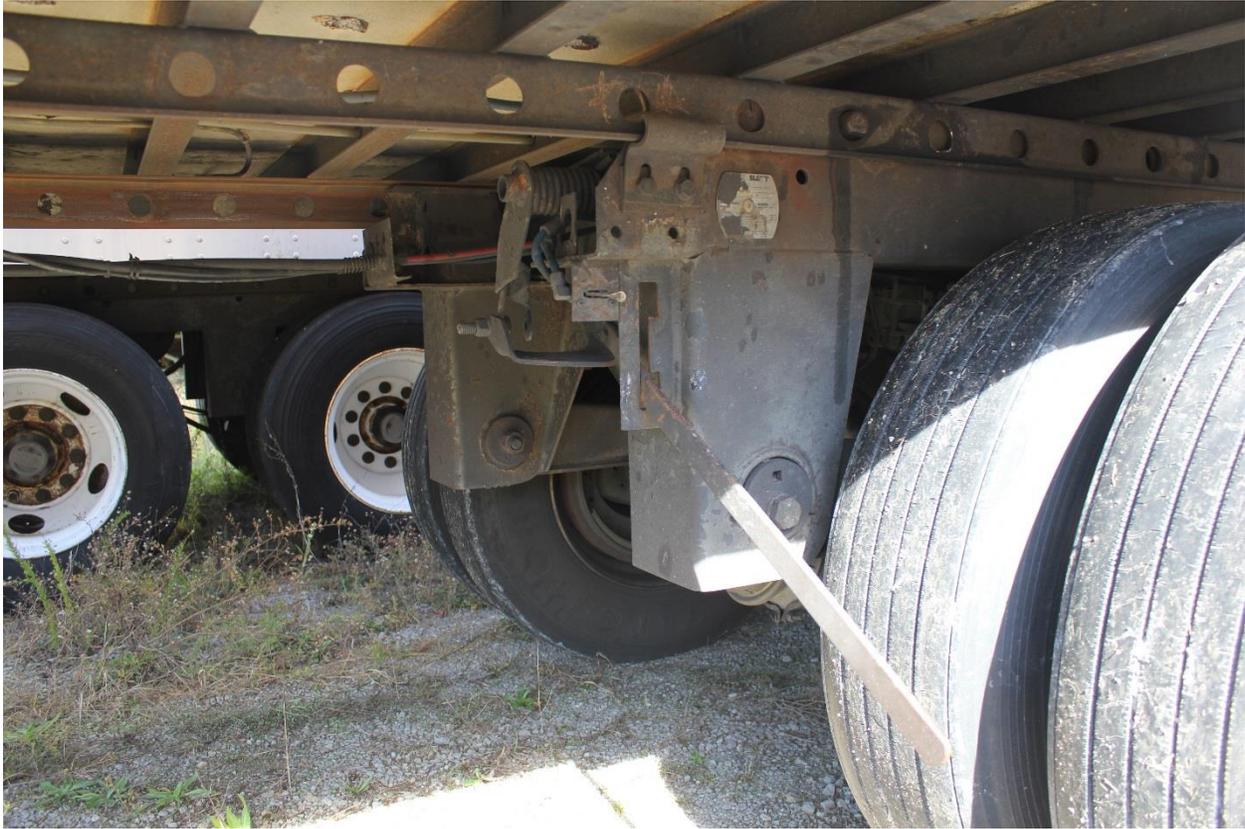
Photo courtesy of KY OSH

On October 30, 2014, at approximately 7:00 am, a semi-truck driver and fellow team driver parked in a chain restaurant parking lot to make their delivery, unloaded their product, and were adjusting the tandems on the trailer. The team driver placed himself near the tandems while the semi-truck driver climbed into the truck cab to rock the truck so that the tandems would slide into place. The team driver was found with his head pinned between the tire and the bottom of the trailer.

driver sprayed WD-40 onto the pins then struck them with a hammer in an attempt to loosen the rust that caused the pins to stick. When the pins were loose, he actuated a manual release lever near the front of the tandem and instructed the semi-truck driver to rock the truck back and forth to release the tandems (see photos #1 & #3).

Recommendation No. 1: Employers should consider providing tools such as extension rods, to allow workers to remain clear of moving or shifting parts.

Recommendation No. 2: Tandem adjustments should be performed by a single driver.

Recommendation No. 3: Drivers should consider using a tandem stopper tool.
