Tow Times®

www.towtimes.com · October 2014

Towing Company Owner's Death Spurs Safety Recommendations

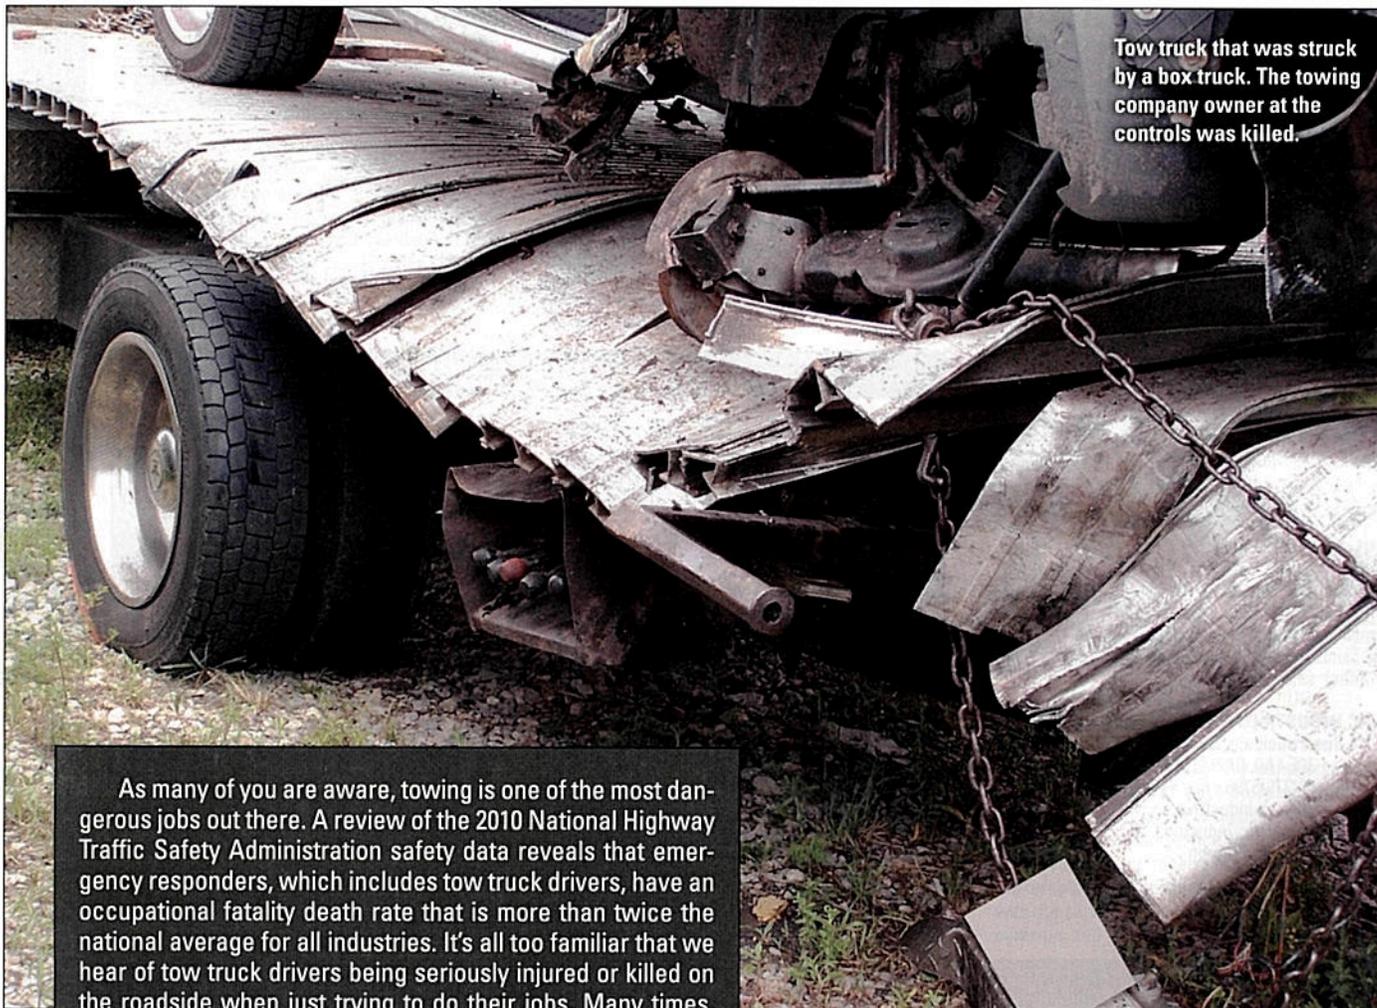
Tow truck that was struck by a box truck. The towing company owner at the controls was killed.

About one hour later, the box truck approached the mile marker where the tow truck driver was snugging up the winch on his load. As the box truck driver approached the parked tow truck he veered right, crossing the solid white line onto the shoulder. The front right side of the box truck struck the rollback section of the parked towing vehicle where the tow truck operator was standing and where the winch controls were located.

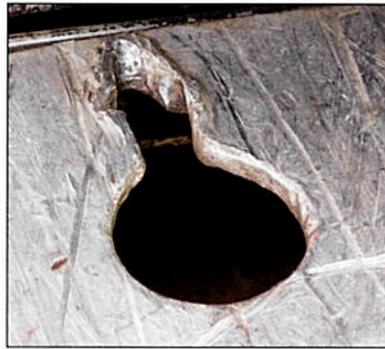
A worn securement site on the tow truck.

The securement sites on the tow truck were stretched beyond their original shape, suggesting the truck had carried loads beyond its maximum capacity. The excess weight of a load can cause a securement site to become warped and misshapen. This could have caused the load to shift back and forth while on the bed of the tow truck, causing it to feel unstable.

Recommendation No. 1: Four points of securement should be used when transporting a load.

Four points of securement should be used when transporting a motor vehicle. The truck only had three points of securement. The four points are located on each corner of the tow truck bed and should be properly fastened to the tires on all four corners of the vehicle. Using less than four points of securement may cause the load to shift back and forth and feel unstable. Additionally, not using all four securement sites can put added stress on the remaining ones, causing them to become stretched.

Recommendation No. 3: The maximum carrying capacity of a tow truck should not be exceeded.

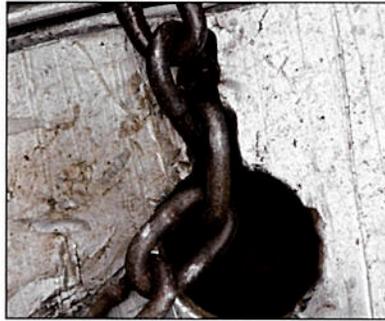
Worn securement site with chain on the tow truck.

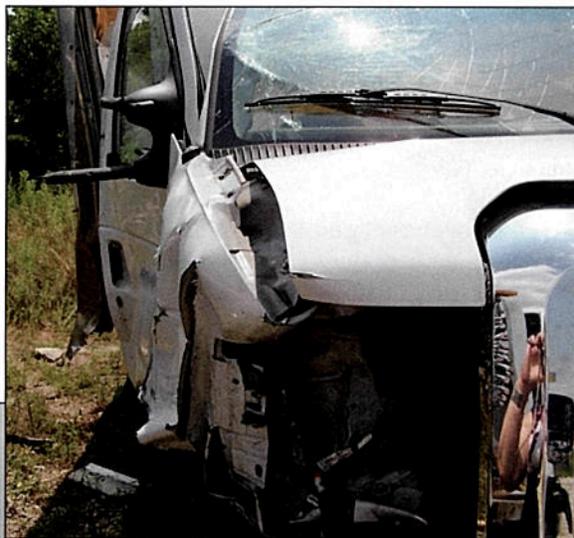
The box truck that struck the tow truck.

The force of the impact against the tow truck sent the box truck careening back onto the interstate in a northward trajectory before flipping onto its side and skidding to a halt some 38 yards away from the tow vehicle. Inside the damaged box truck, the driver remained conscious. The doors in the cab were lodged shut; the driver traversed the back of the cab and the empty cargo space to exit in the rear of the vehicle.
